# Manhole Inspection Summary

Manhole # S25KK\_002MH

Insp Date: **8/28/07 8:57 AM**

**Location** Address: **1300 DRUID HILL AVE**

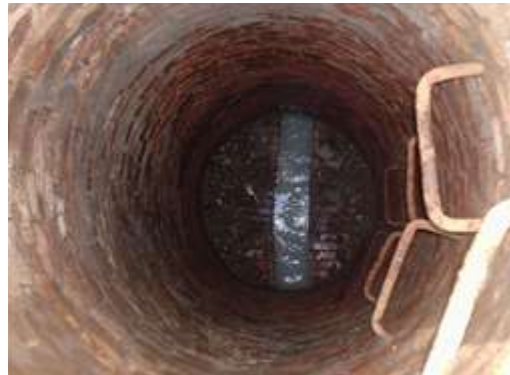
Top View

Corroded steps. Bench debris.

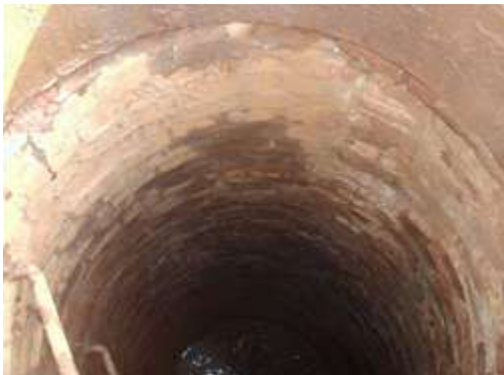
Defect

Frame leaks. Adjustment, Corbel and Barrel infiltration - other side.

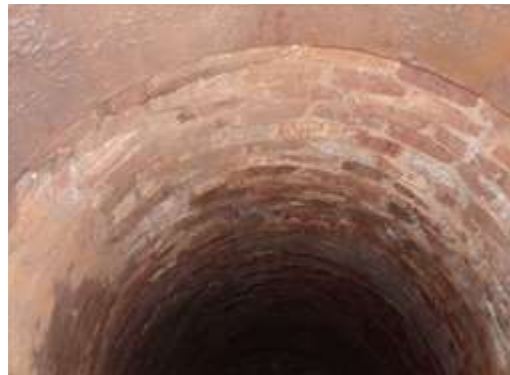
Defect

Frame leaks. Adjustment, Corbel and Barrel infiltration.

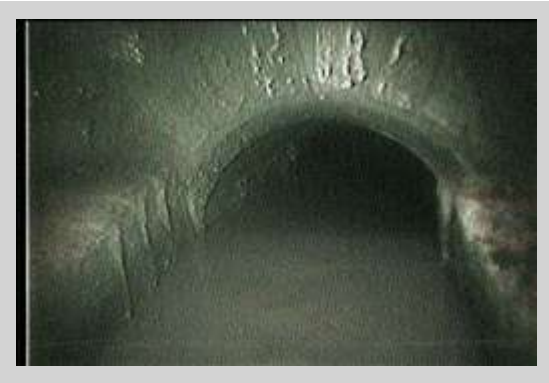
### 10 in. Circular Gravity Sewer Pipe Out @ 12 O'Clock

Pipe Material: **Clay** ☐ Pipe Lined

Invert Depth: **14.00** (ft.) Flow Characteristics: **Fast**

Deposits: ☒ None ☐ Mud ☐ Sludge ☐ Debris ☐ Grease

Infiltration: **None** Pipe Seal Cond: **Unknown**

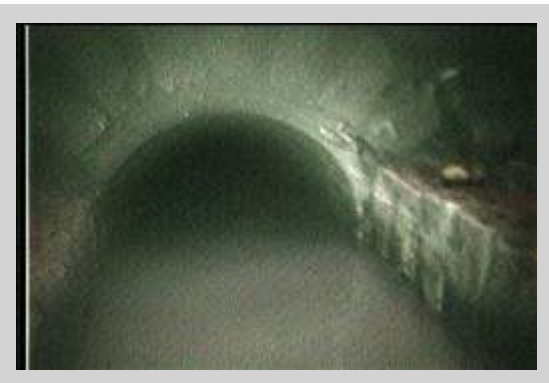
### 10 in. Circular Gravity Sewer Pipe In @ 6 O'Clock

Pipe Material: **Clay** ☐ Pipe Lined

Invert Depth: **13.90** (ft.) Flow Characteristics: **Fast**

Deposits: ☒ None ☐ Mud ☐ Sludge ☐ Debris ☐ Grease

Infiltration: **None** Pipe Seal Cond: **Unknown**
